BERU IgnitionCoil– Retro fitment of 90 degree angled coils to 2002-2009 model

EME Part # BMW-SCoil855
EME Part # BMW-SCoil856

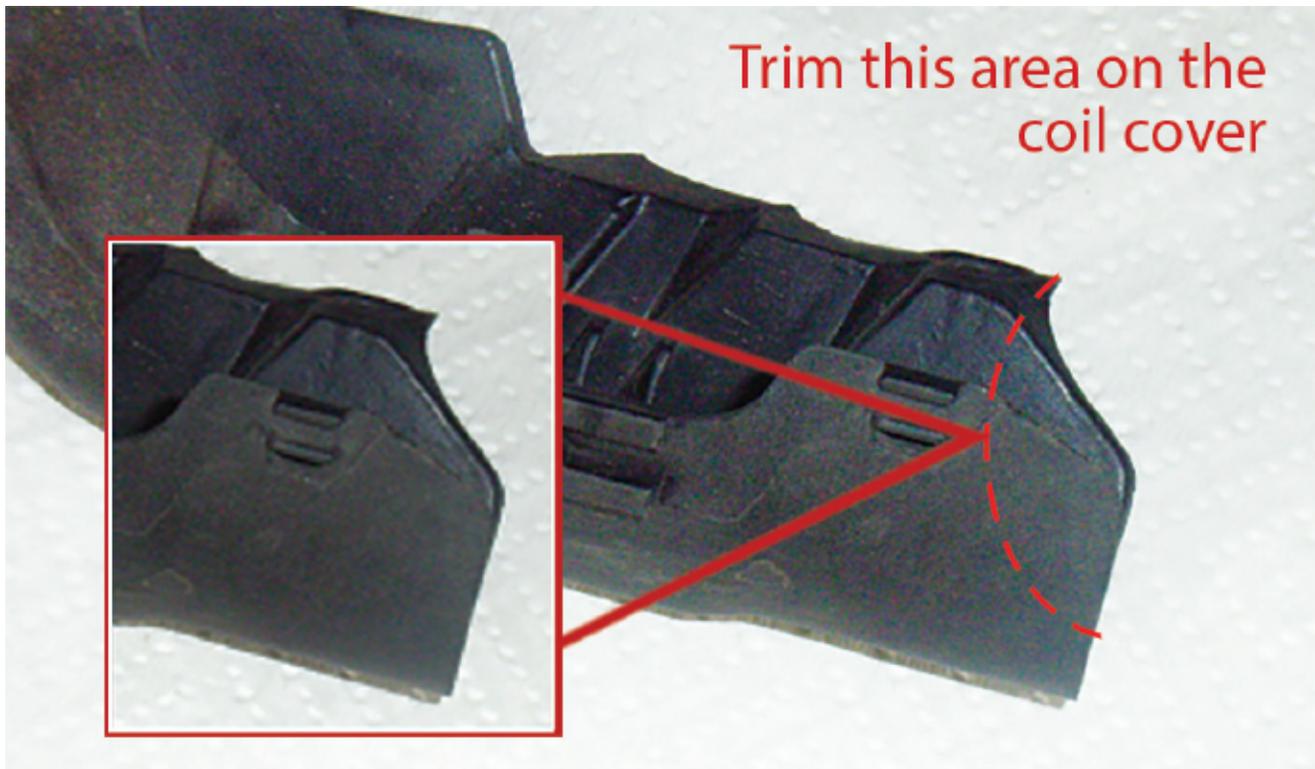
Trim this area on the plastic coil cover

2) The plastic cover that fits over the lower coils need to be slightly trimmed to clear the new connector angle This can be done with snips, scissors or a rotary cutting tool (Dremel, etc) .

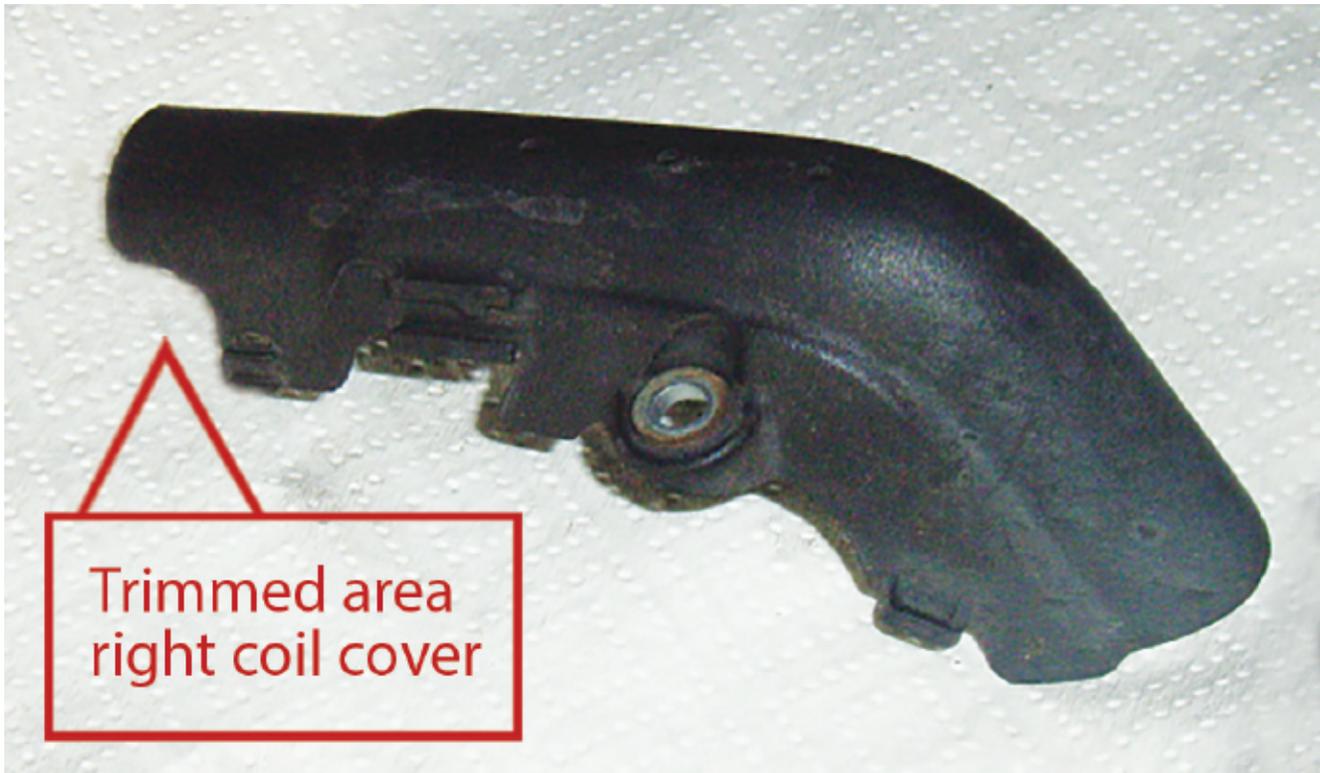
Trimmed area on right coil cover

3) Re-installation is the same as with original coil, however it must be noted that the trimmed plastic Lower coil covers have to compress the newer type rubber grommets that are part of the new BERU 90 degree coils.

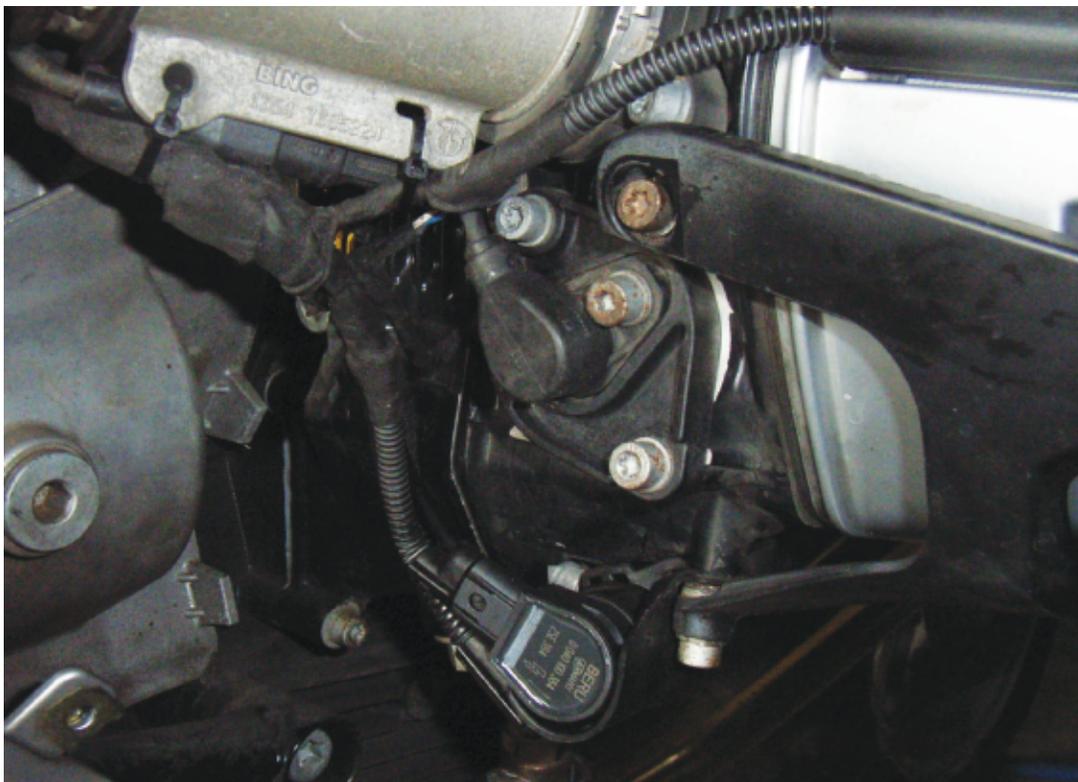
Right side coil cover and coil installed

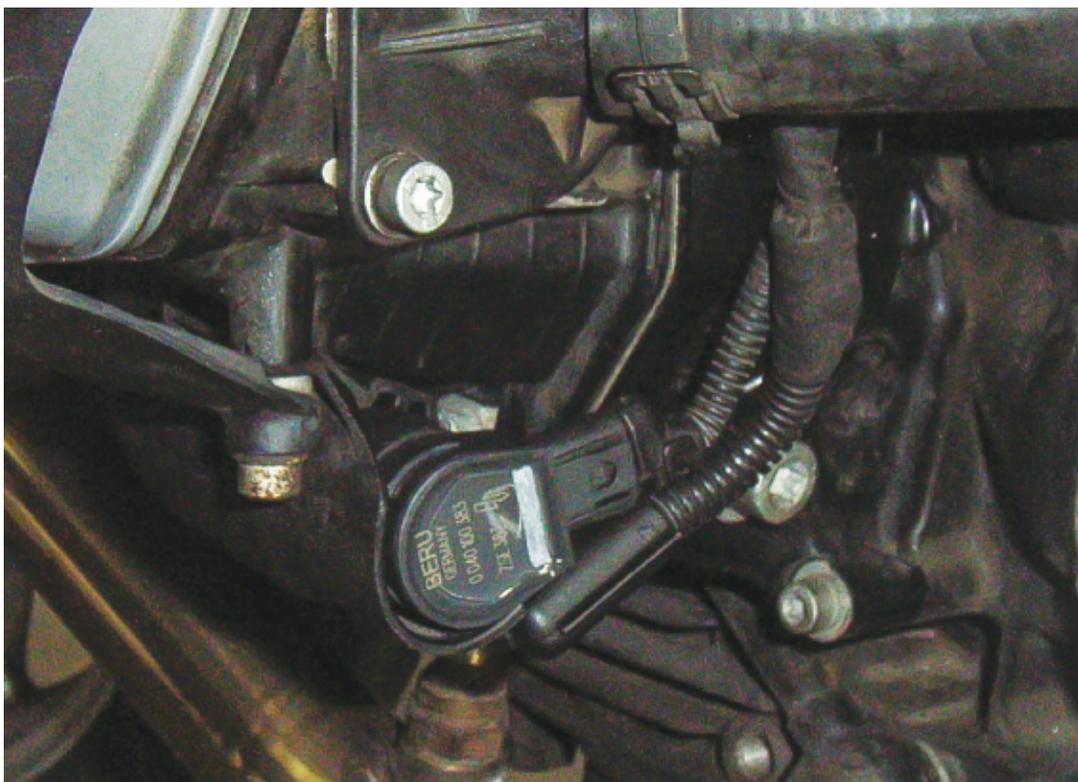
Left side coil cover and coil installed
